# River Ruel Fish Habitat Improvement Project - Progress Report (January 2023)

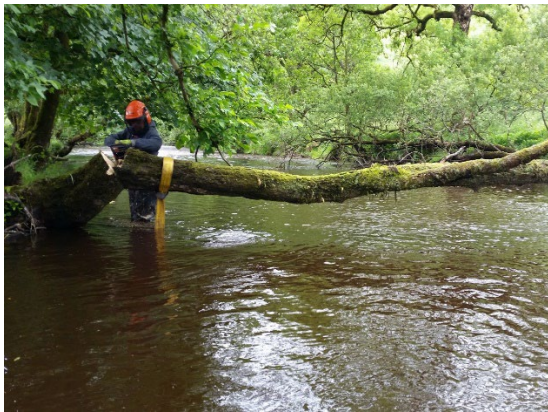
*Fig. 2.1 Felling / coppicing overhung trees to maintain root system*

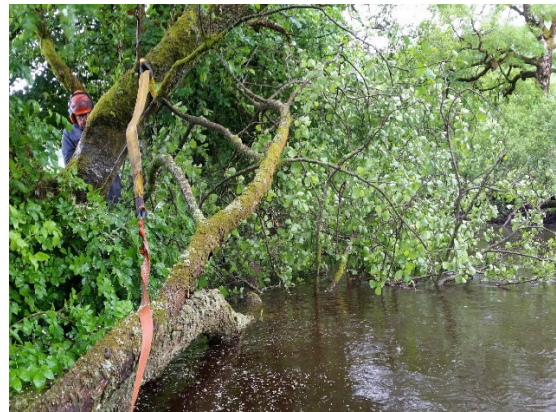
*Fig. 2.2 Felled trees were winched into the bank to provide cover for fish*

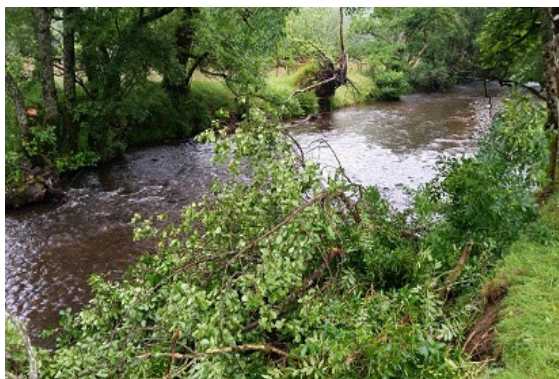
*Fig. 2.3 Felled trees secured into the bank*

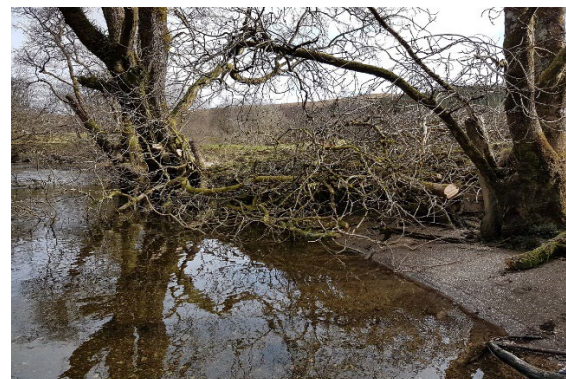
*Fig. 2.4 Coppiced tree limes secured into an eroded bank*

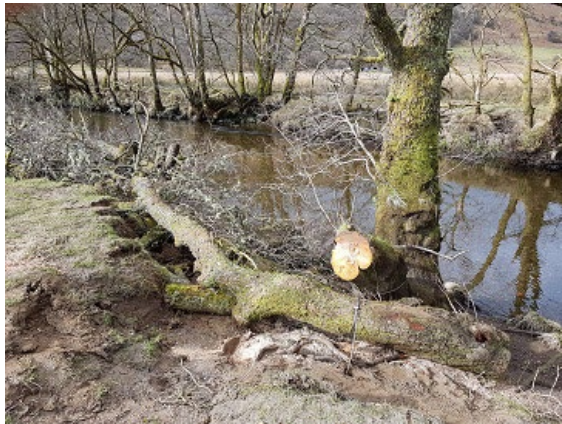
*Fig. 2.5 Coppiced tree limbs secured to protect roots from hoof-shear*

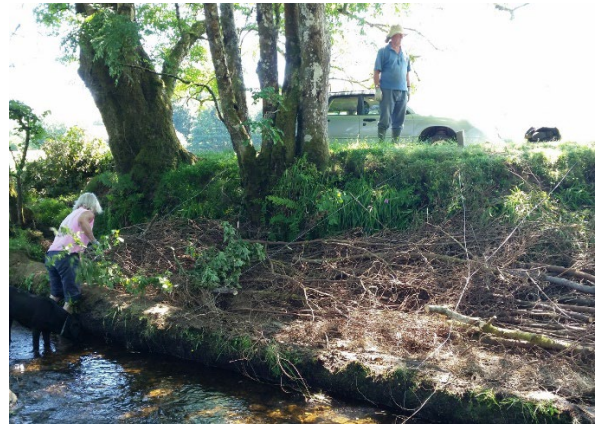
- Coppiced small woody debris (SWD) was also used in green revetment that trap fine sediment, assist the rebuilding of eroded sections of bank and prevent undermining of valuable trees (Figure 2,6).

*Fig. 2.6 Installing green bank revetment to protect existing trees*

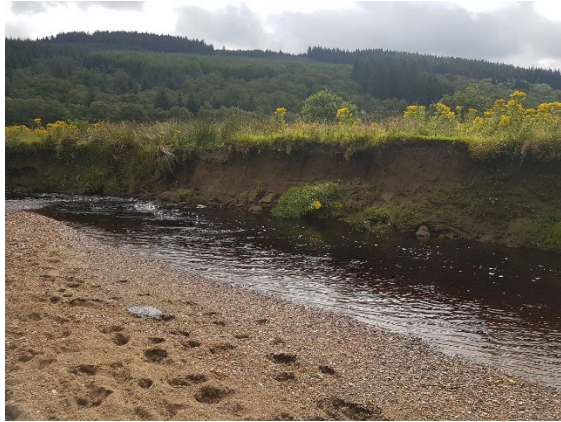
The work carried out in 2022 at Site B1 installed 125 meters of green bank revetment along an eroding face of the River Ruel (Figures 2.7) which contribute significant amounts of soil into the river (Figure 2.8).

*Fig. 2.7 Eroding bank face at treatment site*

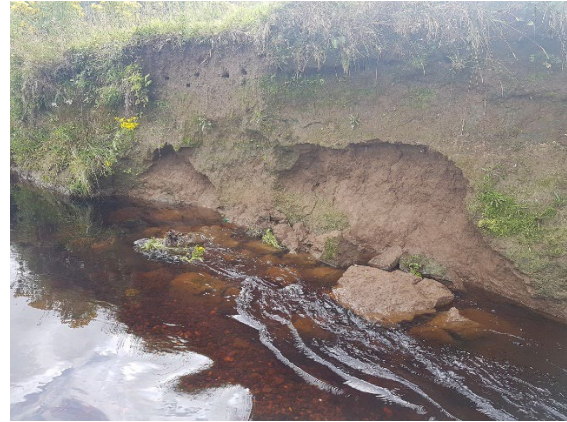
*Fig. 2.8 Bank collapse and soil deposits*

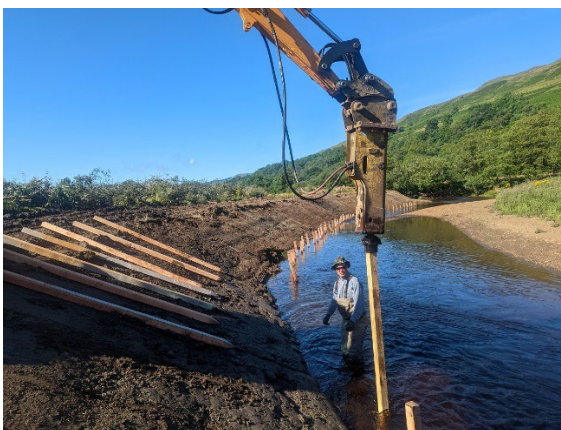
*Fig. 2.9 Installing posts along the reprofiled bank face*

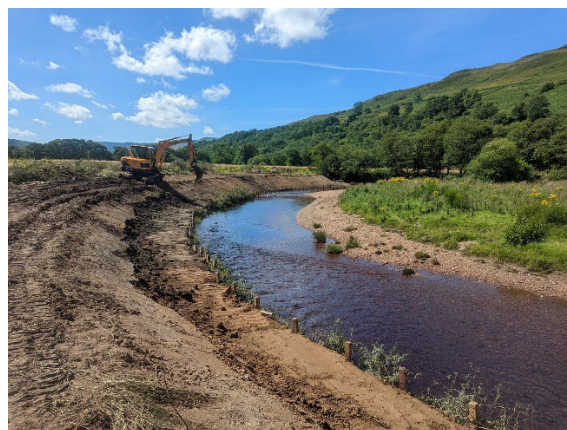
*Fig. 2.10 Track machine securing the bank behind the brush to protect the new bank*

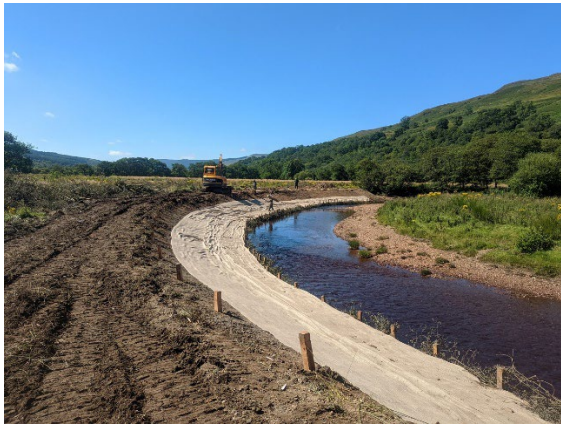
*Fig. 2.11 Hessian layer installed to aid bank recovery and securing posts driven into the top of the bank*

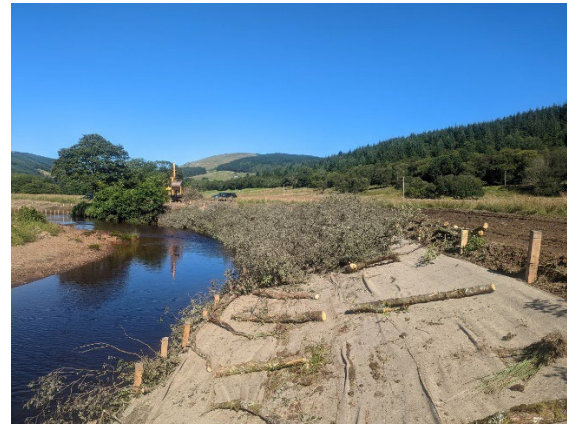
*Fig. 2.12 Willow brush and log laid onto the hessian layer*

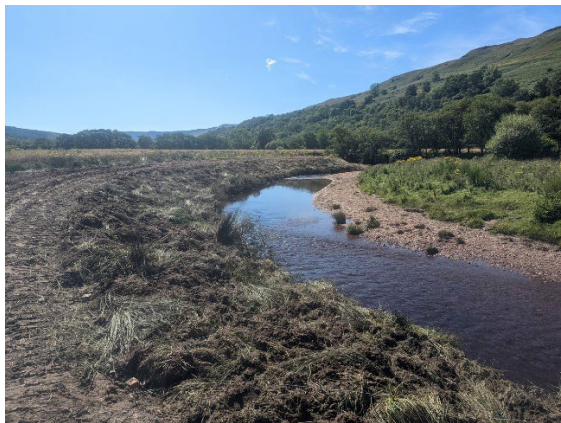
*Fig. 2.13 The turf laid onto the willow secured by a fencing wire lattice.*

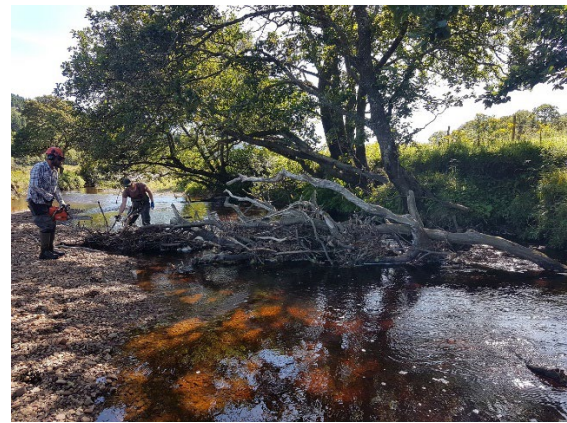
*Fig. 2.14 Reducing a woody debris dam*

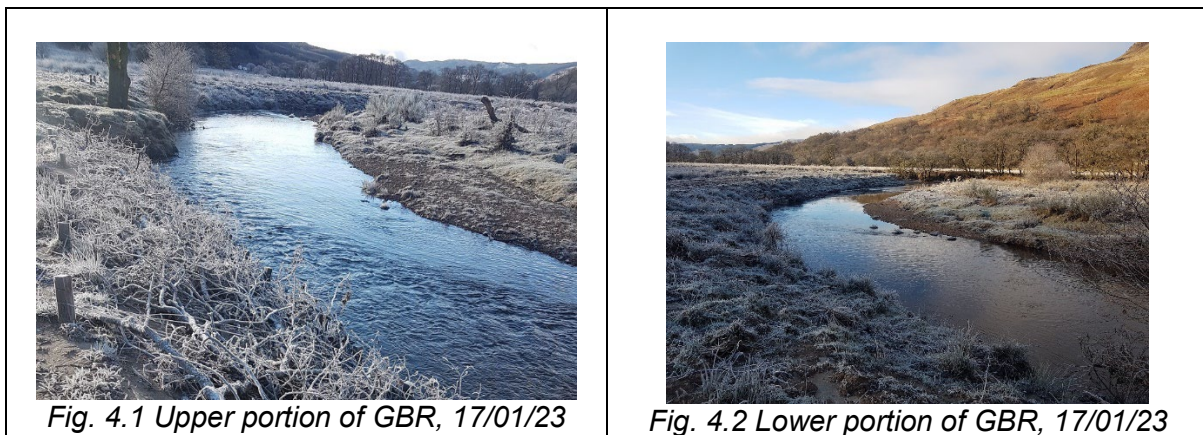
Inspection of the work carried out at site B1 in 2022 was undertaken during a site visit in January 2023 to assess the effectiveness of the GBR installation following several high flow events and inform the development of the project going forward. The inspection found that the treatment stretch had reacted positively to the GBR revetment in that the fine sediment had largely been scoured from the riverbed and substrates appear clean. The substrates also appear to have been redistributed with larger substrates appearing on the outside of the bend and fine sediment being deposited on the inside of the bend. The reappearance of larger substrates on the outside of the bend is a consequence of the riverbed being scoured of fine sediment and prevention of new fine sediment deposited into the river due to the stabilising effect of the new GBR. Reduction of fine sediment in the riverbed has meant that the pool habitats within the stretch have become much deeper and the spawning gravel much cleaner. The brush material installed onto the bank face has also started to accumulate fine sediment

(Figure 4.1) and the turfs placed on top of the brush have been retained and begun to stabilise the bank face vegetation (Figure 4.2).

*Fig. 4.1 Upper portion of GBR, 17/01/23*

*Fig. 4.2 Lower portion of GBR, 17/01/23*

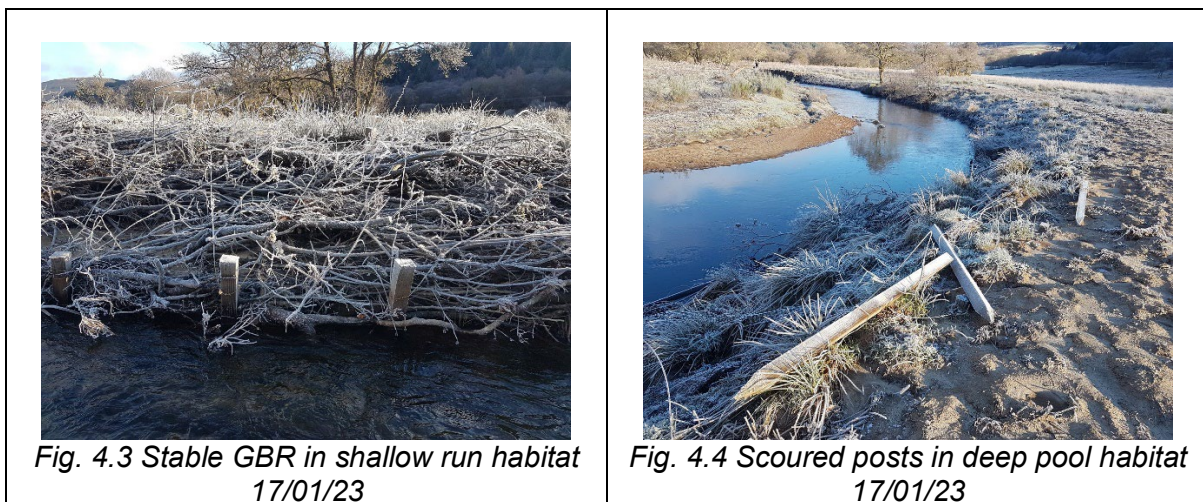
The GBR work was found to be stable in the shallower glide and run flow habitat (Figure 4.3) but were less stable in the two deeper pool habitats where the riverbed in the lower portion of the work area had been soured. Several posts have become undermined by the scouring of the riverbed and had been thrown onto the bank (Figure 4.4). The scouring of the posts is evidence of the changes made in the riverbed profile created by the GBR. The loss of the 1.8-meter-long posts will require that they are replaced with 3-meter-long posts at the two spots affected. The loss of some of the brush behind the lost posts will also need replacement. The repair work will be required on an 18-meter length of the 125-meter-long treatment stretch (15 %).

*Fig. 4.3 Stable GBR in shallow run habitat  
17/01/23*

*Fig. 4.4 Scoured posts in deep pool habitat  
17/01/23*

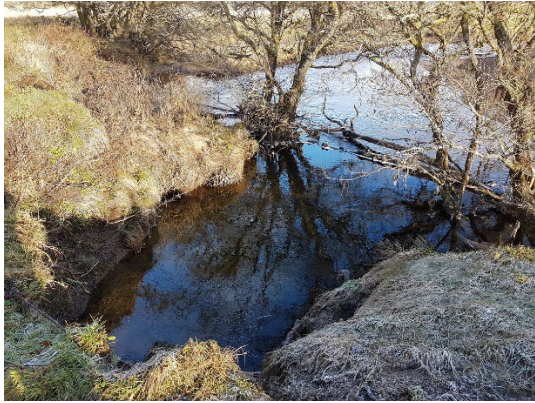
*Fig. 5.1 Undermined trees (site B2a)*

In addition to the repairs to the 2022/23 work at site B1, continued bank stabilisation work is proposed for 2023/24 further downstream at site B2. The work planned for 2023-34 include three activities. Firstly, tree coppicing and large woody debris management along a 25-meter length of bank (site B2a) where the root structures of existing trees are being undermined (Figure 5.1). Secondly, installation of a 96-meter length of GBR (at site B2b) on an eroding and collapsed bank (Figure 5.2) and thirdly, install stock fencing along a 150-meter length of bank to allow the vegetation on the newly treated bank to recover.

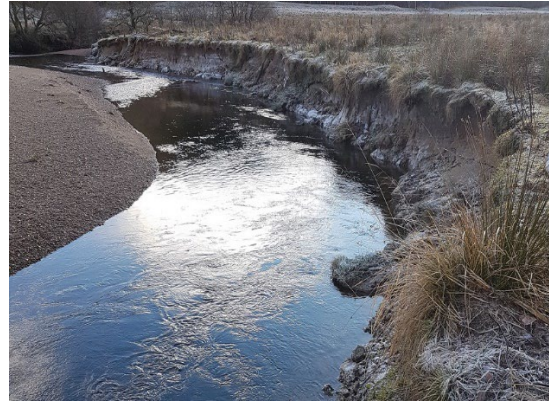
*Fig. 5.2 Eroding / collapsed bank (site B2b)*

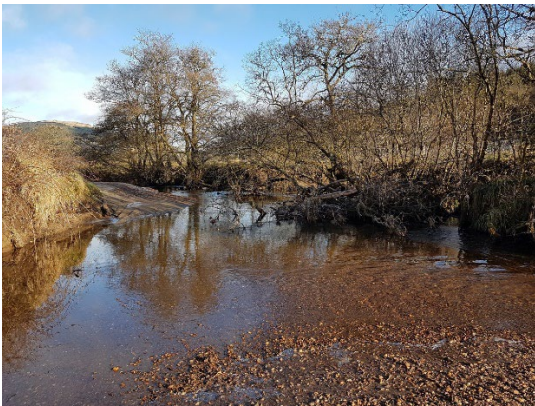
*Fig. 5.3 Unstable bankside trees (Site B3a)*

Given the large amount of habitat in the River Ruel that require improvement work, AFT and RRIA will be seeking additional grant funding (as was the case in 2022/23) to expand the work programme. If additional funds are forthcoming from the Wild Fisheries Fund or other sources in 2023/24, the project partners will undertake further tree management work on unstable bank side trees (Figure 5.3) and GBR on the next section of eroding and collapsing bank (Figure 5.4) further downstream (Site B3).

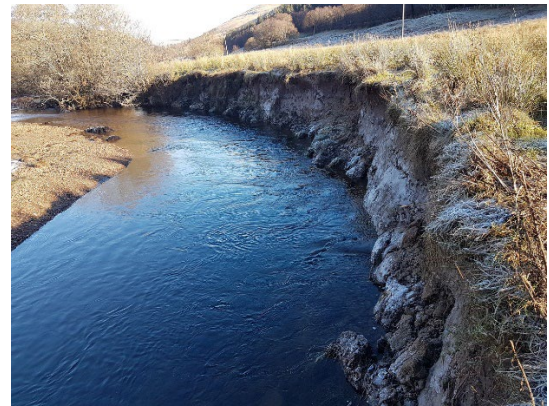
*Fig. 5.4 Bank erosion & collapse (site B3b)*
